**Texas Department of Insurance**

Re: Fire Safety Inspection RRO000000005301A

## **Sam Houston State University Fire Safety Inspection Report**

**Sam Houston State University**  
**Executive Summary**

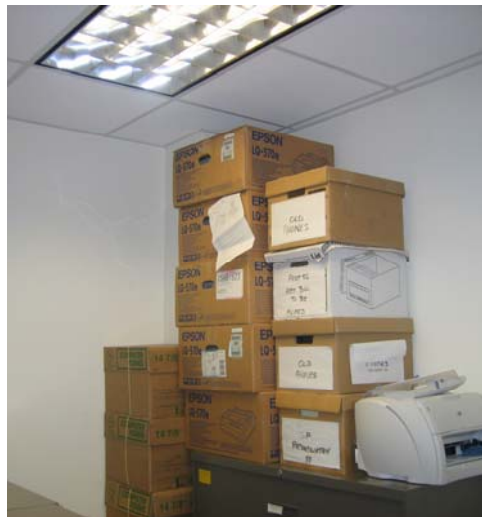
- **The automatic fire sprinkler system lacks required annual servicing. It has not been serviced since its installation on 10-25-00. The lack of servicing may result in this system's failure to function properly.**
- **Room 115E has a corroded sprinkler head, which may prevent it from activating.**
- **Storage in several areas in the building obstructs sprinkler heads. It is within 18 inches of the sprinkler heads. This may lessen effectiveness of the sprinkler system.**
- **A ceiling tile is missing in room 206. This will permit heat to enter the interstitial space, subsequently delaying heat build up and activation of the sprinkler head in this room.**

Fire sprinkler systems must be serviced annually and repaired when impairments are noted. This ensures proper operation in case of a fire. Any device, equipment, system, condition, arrangement, level of protection, or any other feature required for compliance with the provisions of the Life Safety Code shall thereafter be permanently maintained unless the Life Safety Code exempts such maintenance.

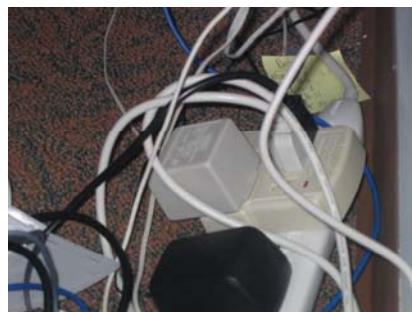
Extension cords are designed and intended for use as temporary wiring. Power strips should not be

interconnected as a means of obtaining additional electrical receptacles.

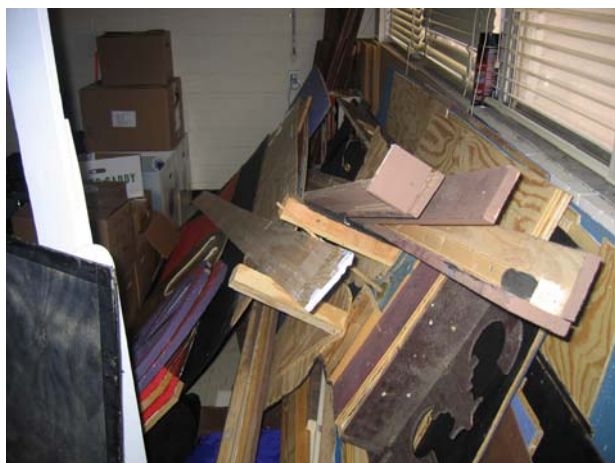
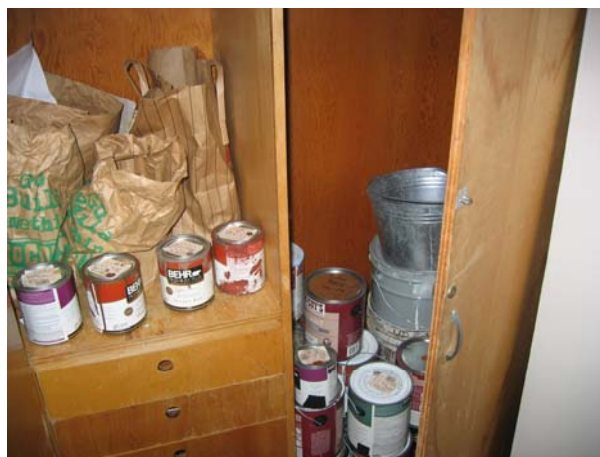
**There is excessive fire load and unapproved storage of flammable paints in rooms 203 and 206. These rooms also lack required separation from the remainder of the building.**

The lack of appropriate storage permits the release of vapors. Vapors will act as an accelerant should a fire occur. Inadequate separation will permit rapid spread of fire occurring in one of these rooms into adjoining areas.

**Remedy:** Properly store flammable liquids within approved cabinets. Provide minimum one hour rated fire barriers separating these rooms. These barriers shall incorporate doors that are minimum 45 minute fire protection-rated and shall incorporate self-closing devices and positive latching.

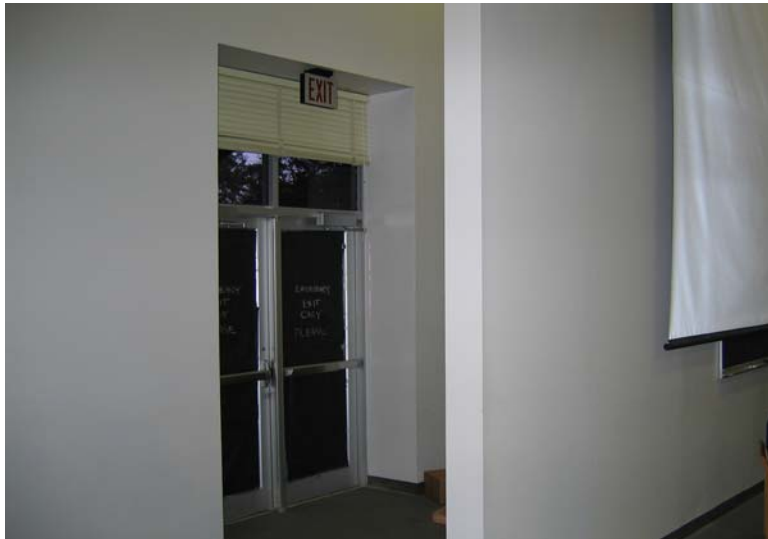
- The secondary exits in the auditorium incorporate exit signs but they lack required visibility from the seating area due to being located behind a partition.
- The exit signs above the main entrance doors are inoperative in both the normal and emergency modes.

Exit signs are intended to provide building occupants with visual indication of the means of egress within a structure, assisting in emergency evacuations. Directional indicators shall be a chevron type that is identifiable as a directional indicator.

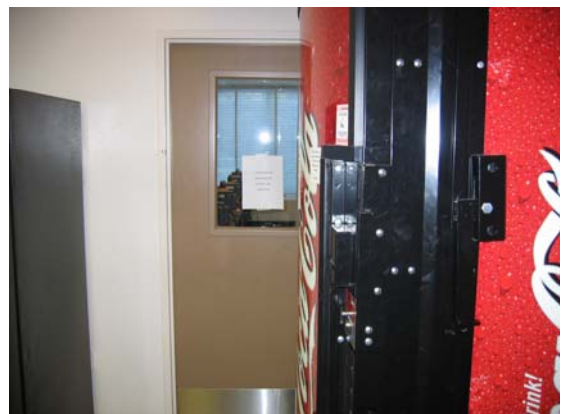
These machines reduce the width of the exit access corridor and may restrict an emergency evacuation. Furnishings, decorations or other objects shall not obstruct exit access, egress or visibility.

**Remedy:** Remove the vending machine and see campus-wide deficiencies located at the end of this report concerning egress obstructions and impediments.

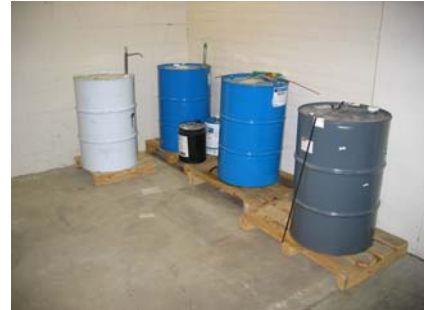
Improper storage of flammable and combustible liquids exists in the basement. This includes flammable liquids consisting of two, 55-gallon containers of isopropyl alcohol and combustible liquids consisting of two, 55-gallon containers of combustible wash and two, five-gallon containers of other combustible liquids.

Flammable Class I liquids are not permitted in basement areas. Combustible Class II and Class IIIA liquids are permitted but must be adequately protected.

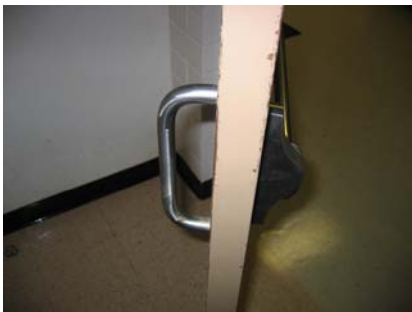
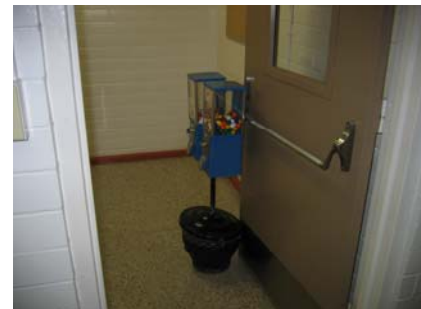
Stair enclosure entry doors lack fire rated hardware and positive latching. The door entering stair enclosure 300S3 is kept open with a gum ball machine.

These doors, and their closing mechanisms, are intended to temporarily contain smoke, heat and flame, should a fire occur. The lack of required hardware or failure to maintain them will adversely affect egress by permitting rapid spread of heat, flame and smoke.

**Remedy:** Install fire rated hardware on each stair enclosure entry door. This hardware shall incorporate self closing devices and positive latching. Discontinue securing these doors in the open position.

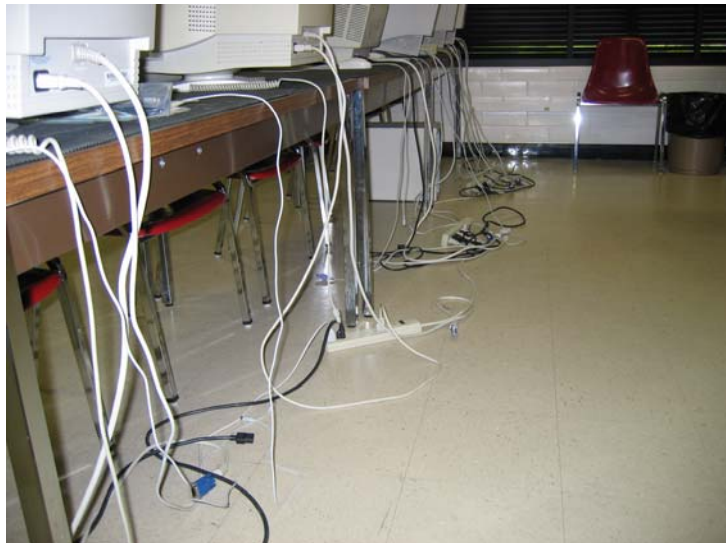
Extension cords are designed and intended for use as temporary wiring. They should not be used as a substitute for permanent wiring. Power strips should not be interconnected as a means of obtaining additional receptacle outlets.

**Remedy:** Discontinue use of the extension cords and interconnection of power strips. See campus-wide deficiencies located at the end of this report concerning the use of extension cords.

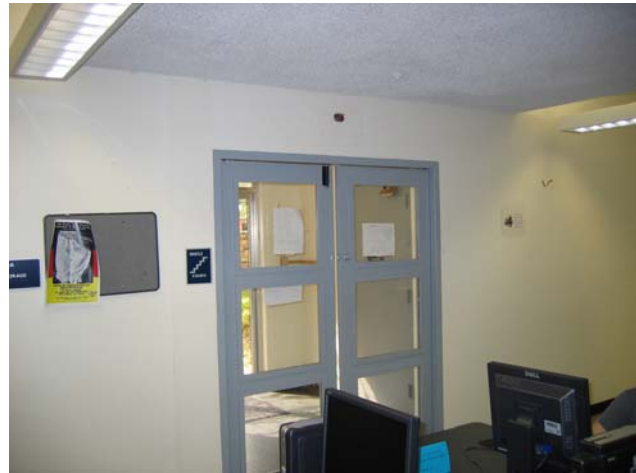
These doors, and their closing mechanisms, are intended to temporarily contain smoke, heat and flame, should a fire occur. The lack of approved doors will permit rapid spread of a fire in lab 110 into the stair enclosures, subsequently preventing use of this exit.

**Remedy:** Replace the existing doors with ones having a minimum 45 minute fire resistant rating. They shall also incorporate self-closing devices and positive latching.

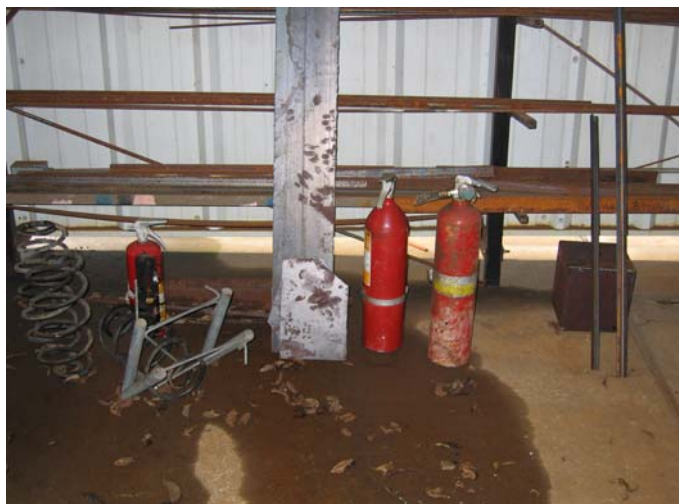
Portable fire extinguishers must be serviced at least once annually. This ensures proper operation in case of a fire. They must be mounted and readily visible to occupants. Any device, equipment, system, condition, arrangement, level of protection, or any other feature required for compliance

with the provisions of the Life Safety Code shall thereafter be permanently maintained unless the Life Safety Code exempts such maintenance.

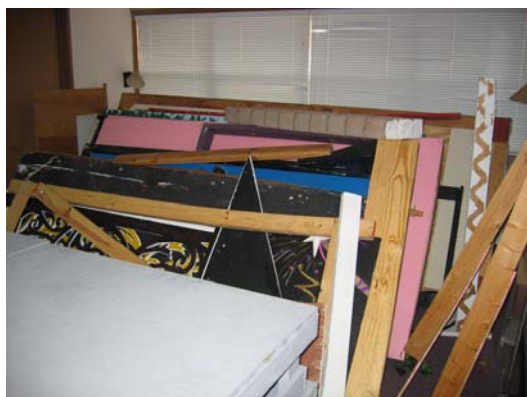
**Combustible items are improperly stored in the building's lobby, including an extensive amount of combustible wooden props.**

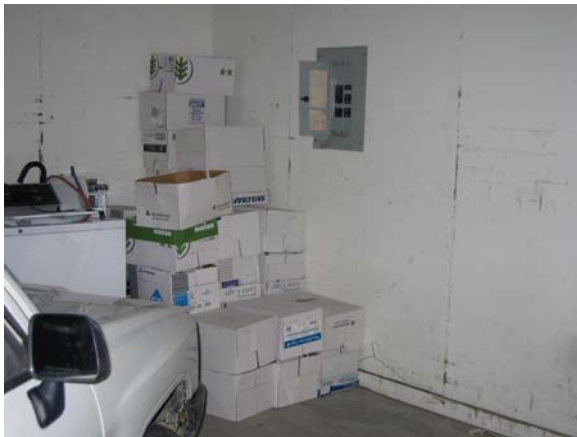
**Empty boxes obstruct access to the electrical panel box.**

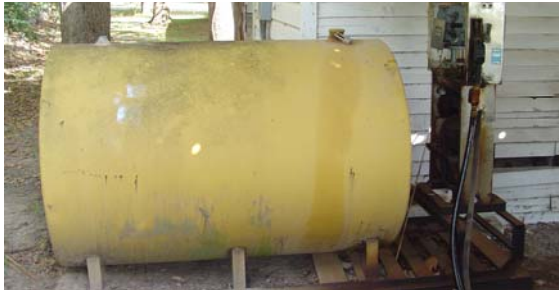
**The aboveground storage tanks and dispenser assemblies lack compliance with less restrictive standards permitted for farms and ranches located in remote areas as per NFPA 30A, *Code for Motor Fuel Dispensing Facilities and Repair Garages, Chapter 13*.**
