**Texas Department of Insurance**

Re: Fire Safety Inspection RRO000000005301A

## **Sam Houston State University Fire Safety Inspection Report**

**Sam Houston State University**  
**Executive Summary**

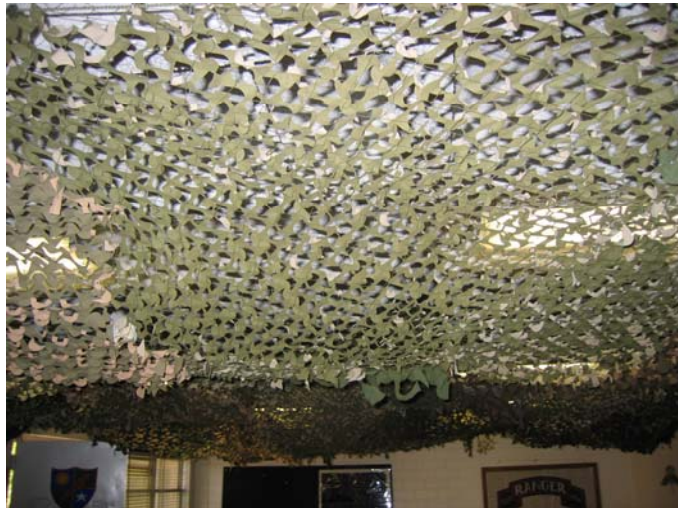
Unapproved interior finishes burn rapidly and thus endanger occupants.

**Remedy:** Remove the camouflage netting. Ceiling areas must incorporate a finish having a minimum class C fire rating.

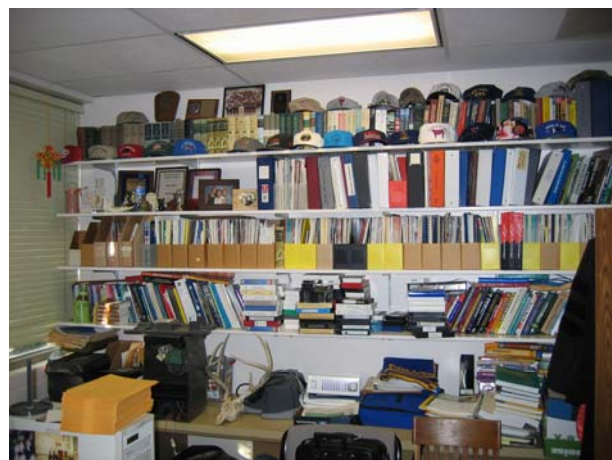
Offices are not permitted to have extensive fuel loads. The extent of combustible material in these offices will fuel a fire, endangering occupants and hindering fire department suppression efforts.

**Remedy:** Implement one of the following two corrective measures:

Enclose the office area with a fire barrier. This barrier shall have a one hour fire resistance rating and shall not incorporate windows. The door entering this office shall

have a minimum 45 minute fire resistant rating, a door closing device and positive latching.

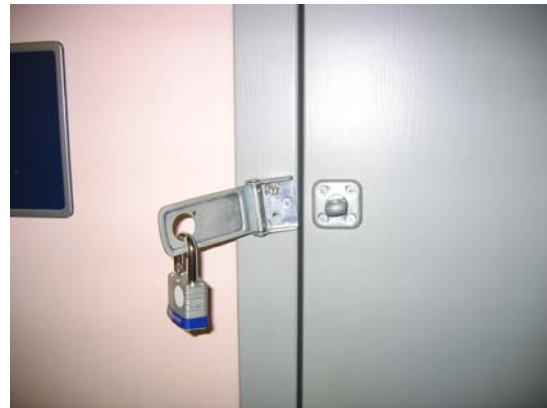
Unapproved devices may result in occupants being inadvertently locked in an area.

**Remedy:** Replace the unapproved locking/latching device with one accessible from the interior side of the room. This replacement device may consist of a key-operated deadbolt, provided the locking mechanism on the interior side of the room incorporates a thumb release.

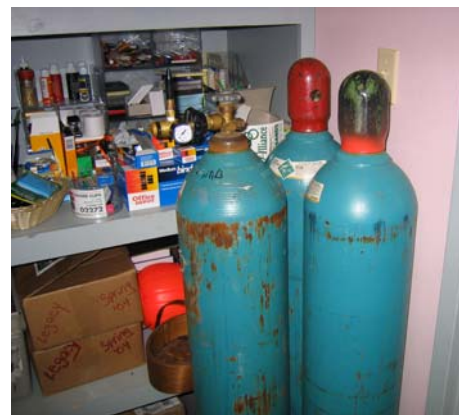
A falling compressed cylinder may accidentally shear the valve, resulting in a release of gas and causing the cylinder to act as a projectile. This projectile may cause damage resulting in a threat to life and property.

**Remedy:** Secure the gas cylinders to prevent accidental tip over.

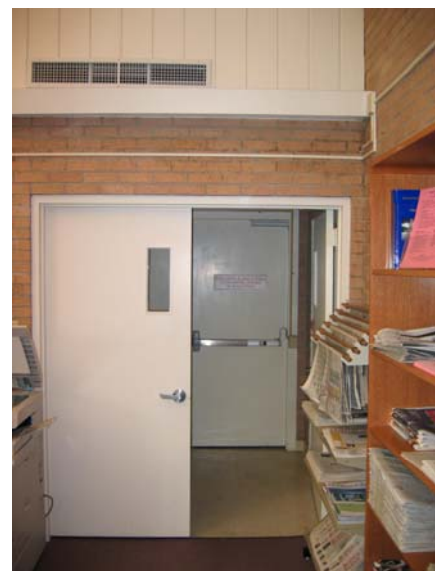
Exit signs are intended to provide building occupants with visual indication of the means of egress within a structure, assisting in emergency evacuations. Directional indicators shall be a chevron type that is identifiable as a directional indicator.

**Remedy:** Install an illuminated exit sign above the door leading to the exit and see campus-wide deficiencies located at the end of this report concerning marking of means of egress with exit signs.

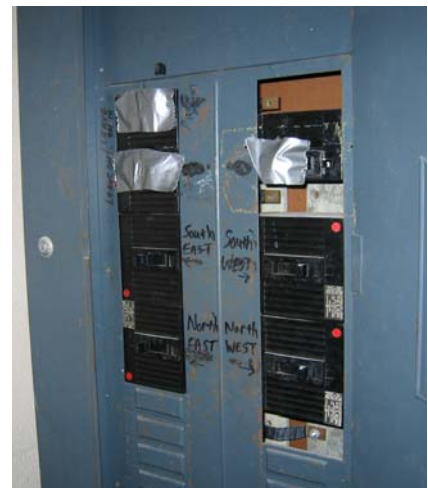
**The electrical panel box breakers located in the closet are inappropriately taped in the open position.**

Taping these breakers open hinders their ability to trip during a short or other malfunction, which increases the risk of fire.

**Remedy:** Remove the tape from all breakers and maintain them in the proper working order.

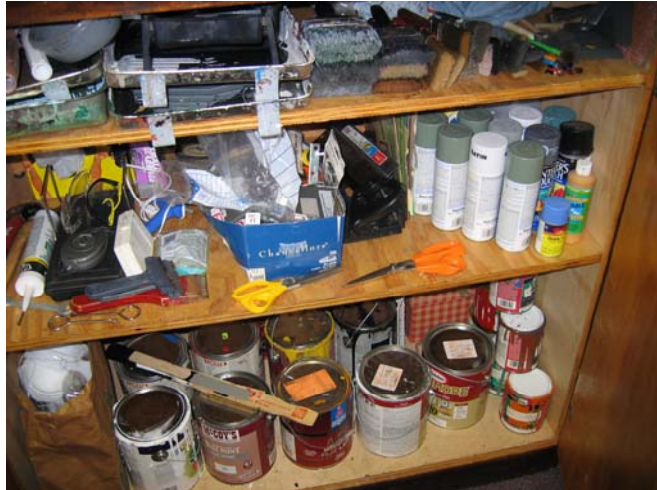
**Unapproved storage of flammable paints exists in room 102. This room also contains an extensive amount of combustible materials.**

The lack of appropriate storage for flammable liquids permits the release of vapors, which will act as an accelerant should a fire occur. The extensive combustible material will also fuel a fire.

**Remedy:** Implement the following corrective measures:

Provide an approved cabinet for the storage of flammable liquids or remove the liquids. Provide the area with a minimum one hour fire barrier separation. Doors entering this area shall consist of 45 minute fire rated doors with self closing devices and positive latching.

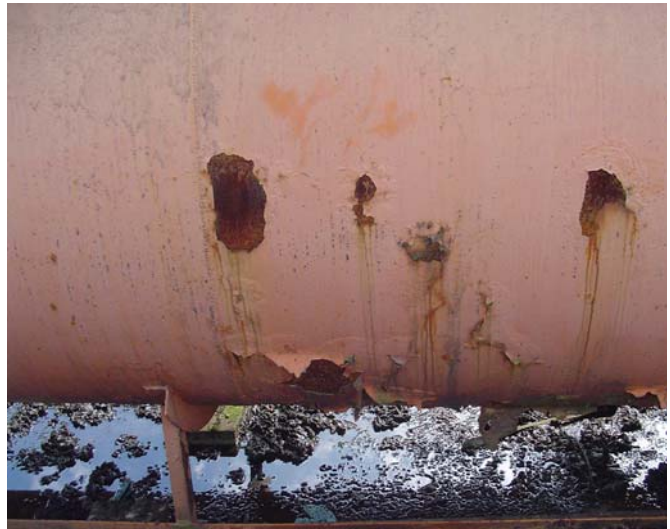
**The above-ground storage tank lacks a label indicating if it is designed and constructed in accordance with recognized engineering standards or approved equivalents. Tank corrosion is visible in several locations.**

Atmospheric tanks, including those incorporating secondary containment, shall be designed and constructed in accordance with recognized engineering standards or approved equivalents.

**Remedy:** Replace the existing AST with one meeting one of the following standards.

UL 142, Standard for Steel Aboveground Tanks for Flammable and Combustible Liquids; UL 2080, Standard for Fire Resistant Tanks for Flammable and Combustible Liquids; or UL 2085, Standard for Protected Aboveground Tanks for Flammable and Combustible Liquids

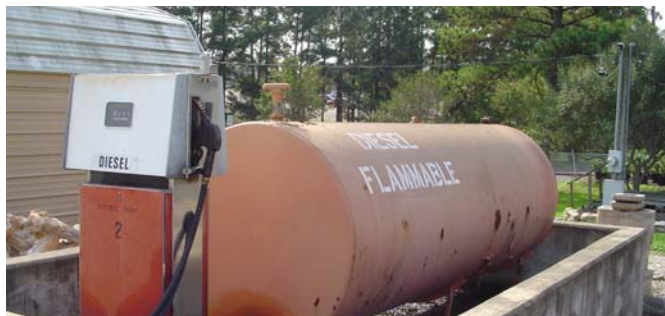
This tank, exposed to a fire, may result in the contents developing sufficient pressure to cause a tank rupture. This endangers firefighters and nearby buildings.

**Remedy:** Replacement of the existing tank with one meeting minimum standards will require installation of an

emergency relief vent.

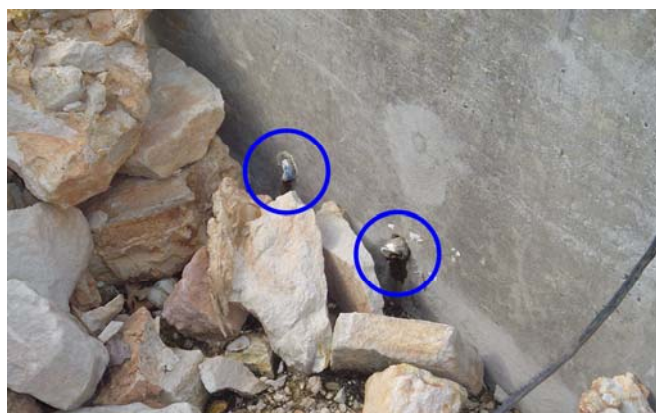
Spill containment must be maintained. Every tank that contains a Class I, Class II, or Class IIIA liquid shall be provided with means to prevent an accidental release of liquid from endangering important facilities and adjoining property or from reaching waterways. Such means shall include remote impoundment, impounding around tanks by diking, or an integral secondary containment tank.

**Remedy:** Provide one of the pipes with a cut-off valve. This valve shall be kept closed unless emptying rain water from the spill containment areas. Effectively seal the second plastic conduit.

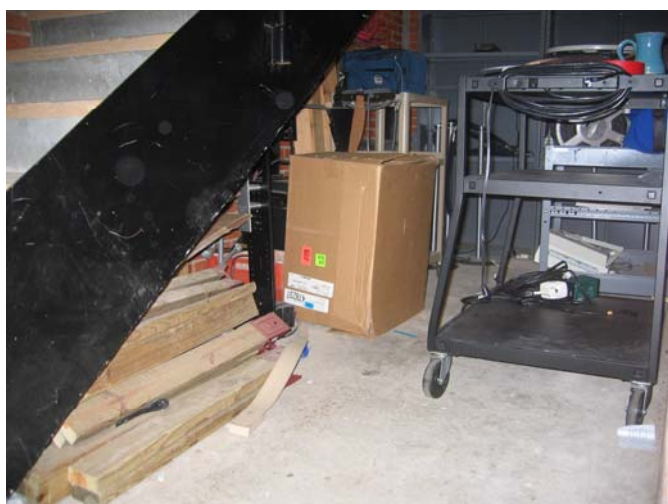
This storage will fuel a fire, should one occur.

**Remedy:** Eliminate the combustible storage. Discontinue using egress stair enclosures for storage.

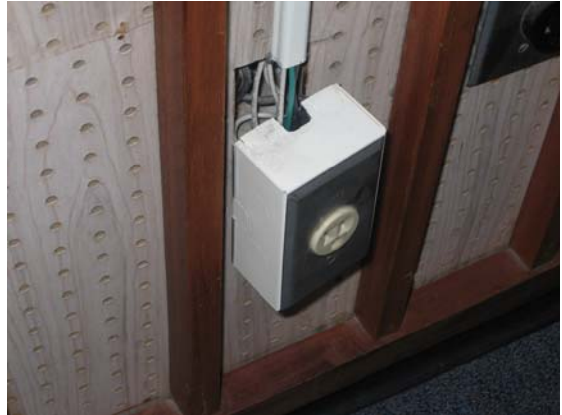
Electrical boxes, panels, fixtures, etc., must be rigidly anchored to a substantial surface. The insulation protecting the electrical conductors may be damaged when having to support fixtures.

**Remedy:** Anchor the electrical receptacle box to the wall.

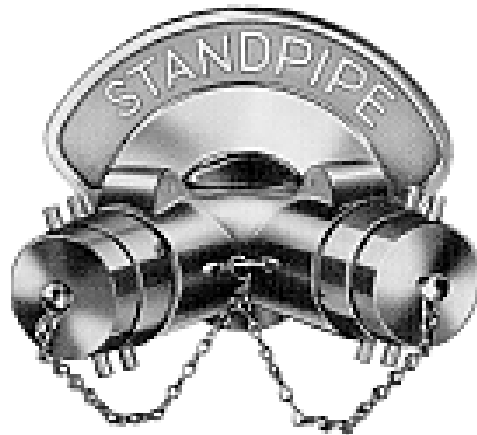
**The standpipe fire department connection on the exterior of the building is not identified as to what type of system it serves. This may result in confusion during firefighting operations.**

**Remedy:** Install a sign at the fire department connection. It shall have raised letters, at least inch in height and cast on a plate or fitting that reads "STANDPIPE."

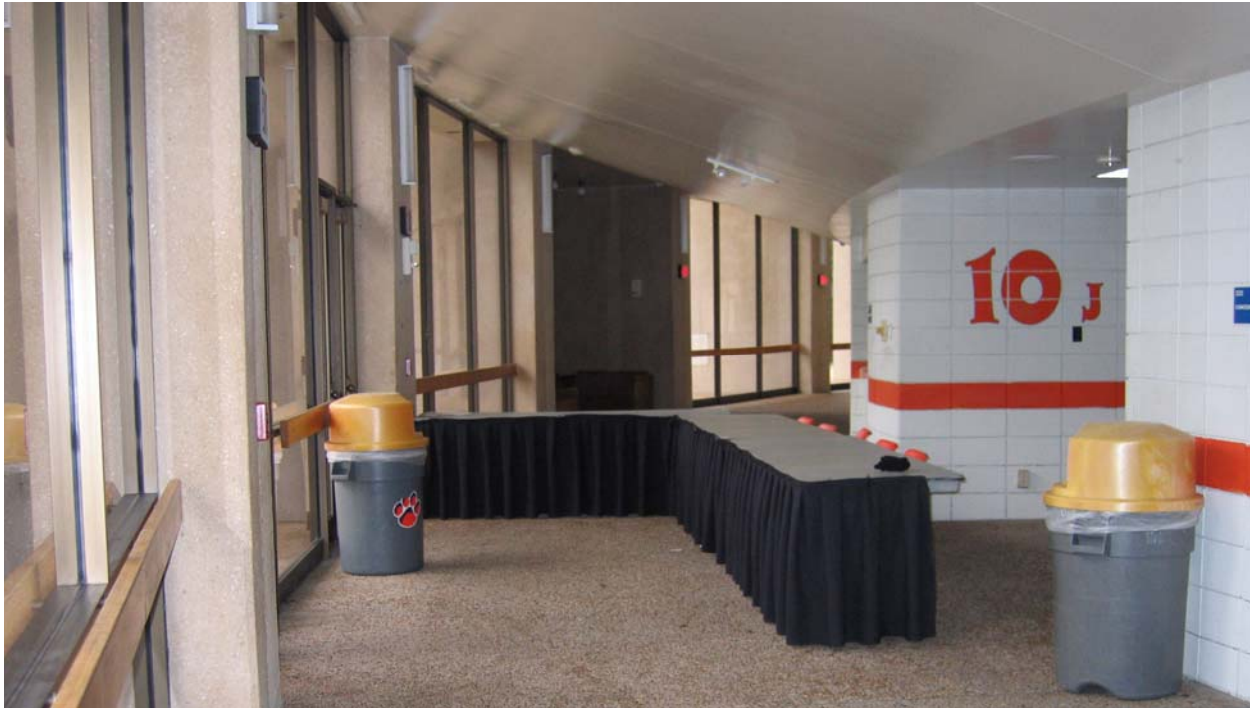
**Tables and chairs arranged for special events block exit routes in the concourse. In case of an emergency, the evacuation of occupants will be delayed by furnishings that are blocking exit pathways.**

Means of egress from all parts of the building shall be maintained free, unobstructed and accessible to ensure reasonable safety for occupants. Furnishings, decorations or other objects shall not obstruct exit access, egress or visibility.

**Remedy:** Remove the tables and chairs blocking the concourse. Develop a plan for all events to ensure that reception tables, concession sales, display booths, etc., do not impede exit pathways.

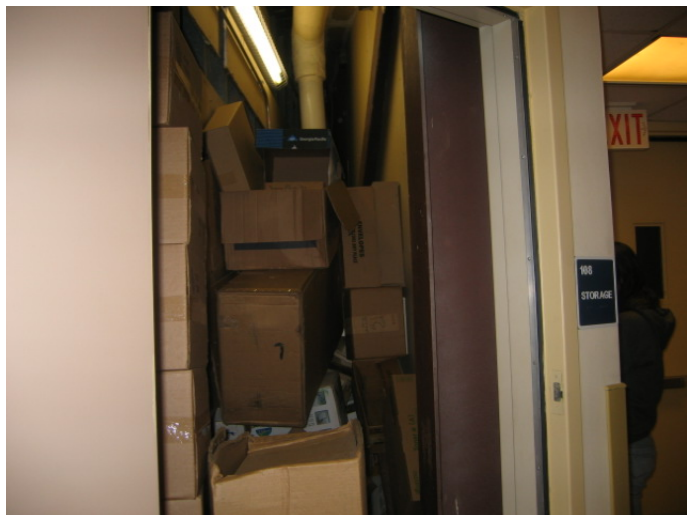
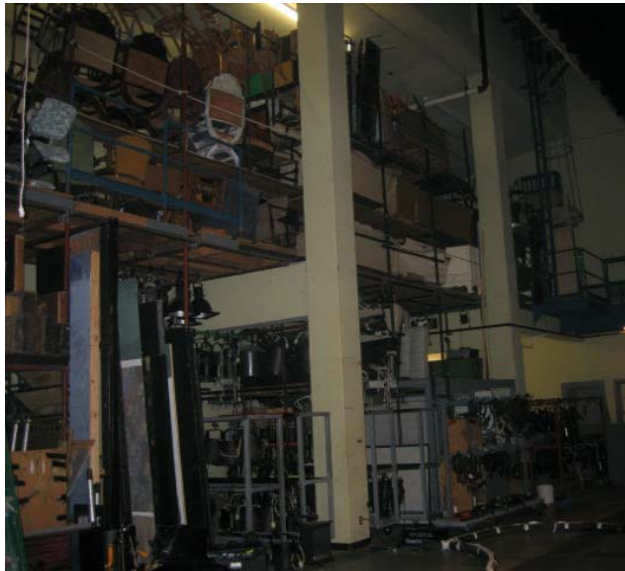
**Numerous areas throughout the building are extensively filled with combustible storage. These areas include areas/rooms not originally designed or intended for storage. Occupants within numerous areas are exposed to this storage. These locations include, but may not be limited to, the following:**

- **Second floor storage rack.**
- **Room 137, second floor.**
- **Catwalk area at main stage.**
- **Room 108.**

This extensive storage is creating a tremendous fuel load for a fire, should one occur. The extent of storage presents a substantial threat to occupants and fire fighters. It

appears that storage through the years has not been purged upon receipt of donated items, resulting in a serious threat to life.

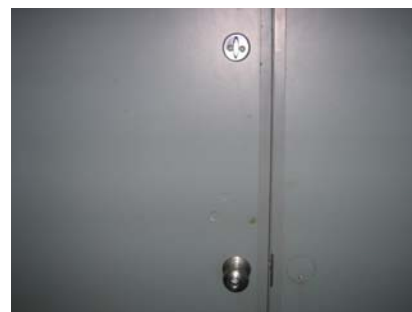
##### **The exit access door from room 303 improperly incorporates more than one release device. One of these devices is incorporated into the door knob and the other is a double cylinder deadbolt lock.**

A means of egress shall not require more than one device to release and open a door. The door does not require use of both devices upon activation of the fire

alarm system. However, the current configuration fails to comply with minimum standards required for delayed and/or access-controlled egress devices.

Unapproved locking and/or latching devices may hinder egress and thus endanger occupants.

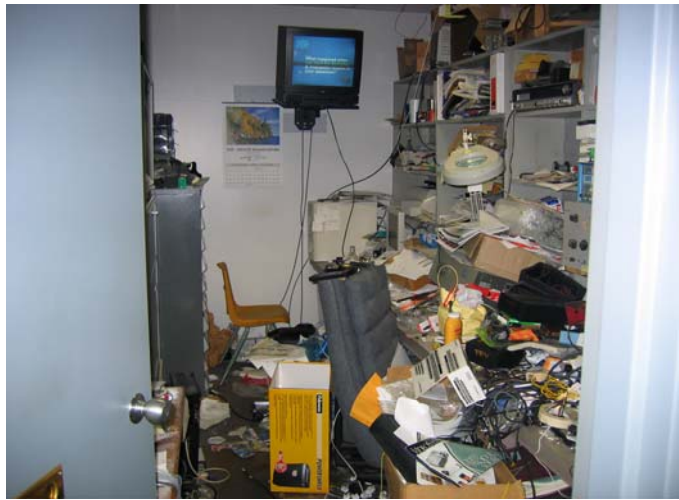
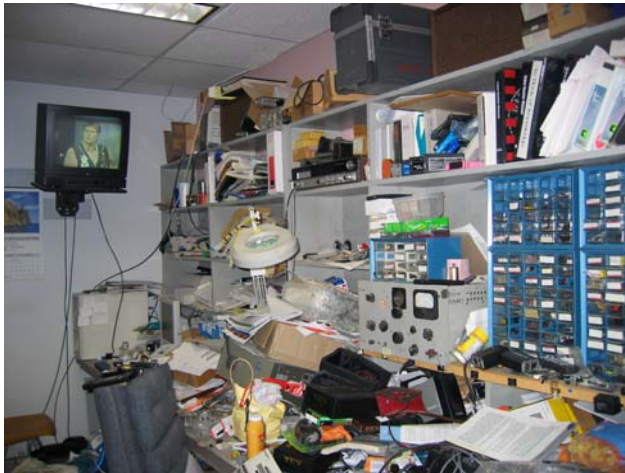
A large concentration of combustible items exists in offices 126 and 203. The extensive amount of combustibles in this office exceeds what is typically found within such rooms and thus results in them being categorized as hazardous areas.

Offices are not permitted extensive fuel loads. The extent of combustibles in these offices will fuel a fire, should one occur, subsequently endangering occupants and hindering fire department suppression efforts.

**Remedy:** Implement one of the following two corrective measures:

Enclose the aforementioned office areas with fire barriers. These barriers shall consist of a one hour fire resistance rating and shall not incorporate windows. The doors entering these offices shall consist of ones having a minimum 45 minute fire resistant rating, door closing devices and positive latching.

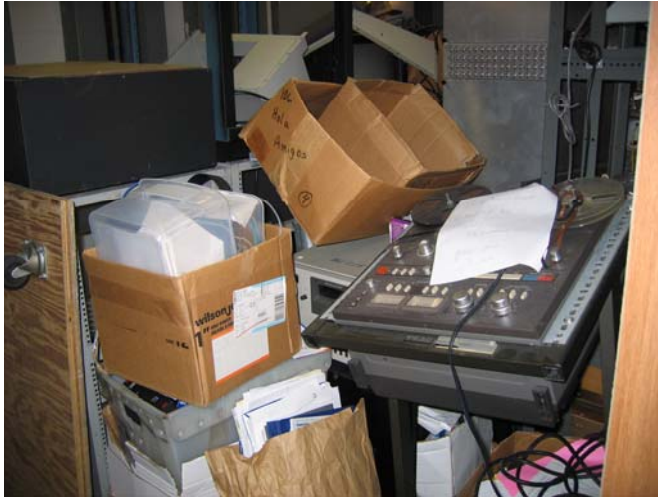
## FINDING #11

### **Mechanical room 100U1 is used for storage of unrelated items.**

Mechanical rooms are intended to house equipment and related items. Unapproved storage may result in a fire and/or hinder fire department access. This storage also hinders access to the equipment and utility supply.

**Remedy:** Remove all unrelated storage from the mechanical room.

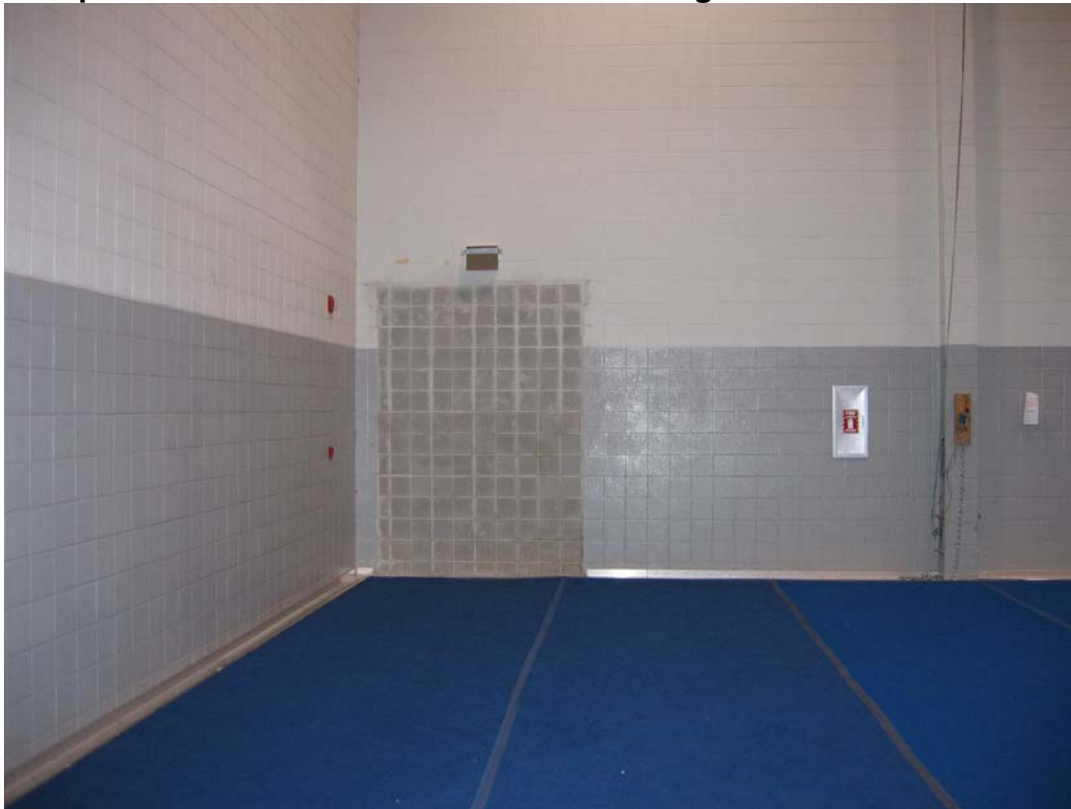
## FINDING #2

The required second exit in Aerobics room 147 has been eliminated and filled with concrete blocks as part of a building expansion. This room has a posted occupant load of 200 and now limited to a single exit.

One exit presents a risk of a fire blocking this single exit, subsequently trapping occupants.

**Remedy:** The occupant load of this room was restricted to not more than 49 occupants until a second means of egress is provided.

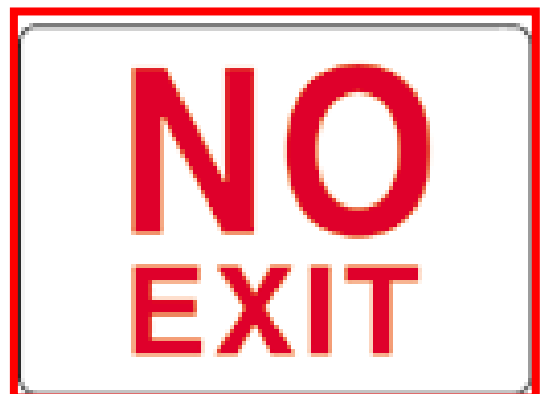
This situation may delay evacuations due to occupants attempting to use these identified exits.

**Remedy:** Two other exit access doors discharge to an egress corridor from the gym and another door permits access to the adjoining gym, which

has additional egress. Therefore, this condition permits the following corrective measures:

- Install signs on the two doors that are no longer available as exits. This signage shall state "NO EXIT". These signs shall remain until the doors are effectively sealed and no longer appear as exits.
- The exiting doors in one gym do not meet remoteness requirements. Therefore, remove the accordion gate at the passageway between Gyms 1 and 2.

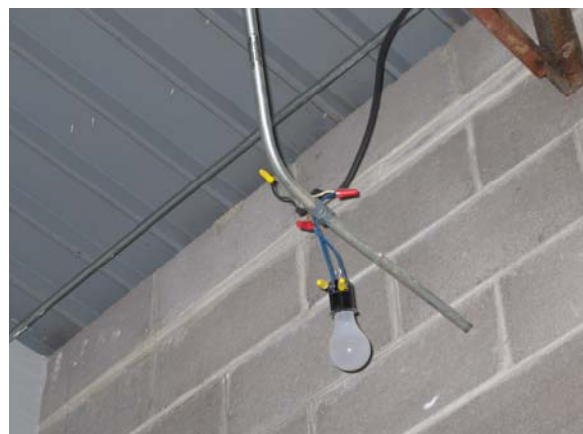
#### **FINDING #7**

**The light fixture in storage room 200U4 is supported by the electrical conductors supplying the fixture.**

The weight of the fixture may result in severing the electrical conductor insulating jacket, resulting in an electrical short, subsequently causing a fire.

**Remedy:** Contact a licensed electrician to remove the existing lamp holder and install a permanent light fixture meeting the requirements of NFPA 70, *National Electrical Code*. Luminaries (fixtures) and lamp holders shall be securely supported and attached to some building structural member.

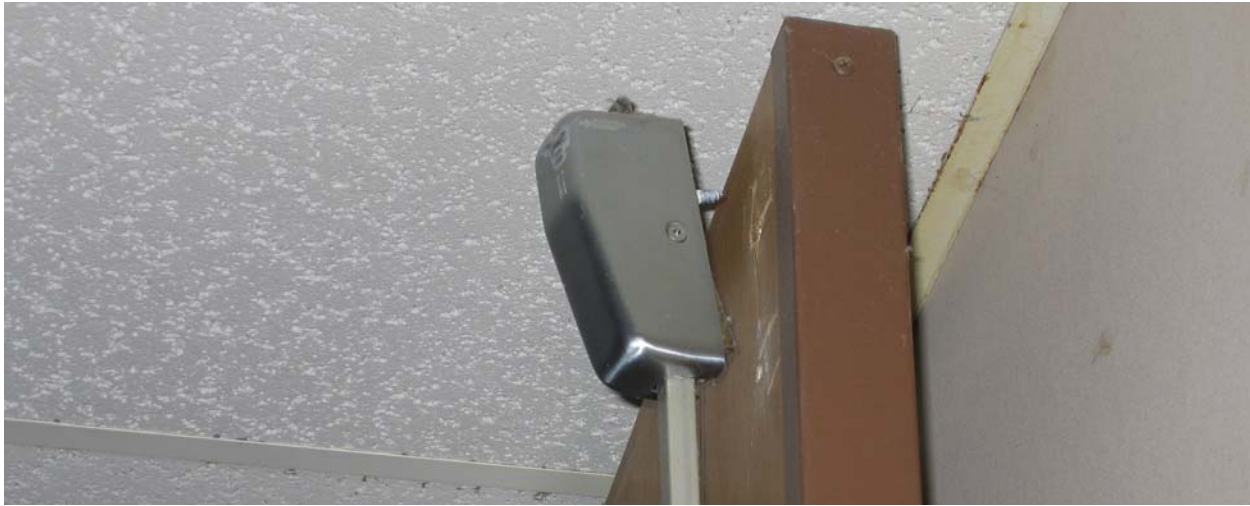
## **FINDING #4**

**The atrium is separated from other parts of the building. However, the integrity of the opening protection is destroyed because door latching hardware located at the top edge of the doors has been dislodged.**

The lack of positive latching will permit the forces generated from a fire to push the doors open, subsequently permitting heat, flame and smoke to enter the egress corridors.

**Remedy:** Repair or replace all non-functioning door hardware. NFPA 80 recommends the use of bolts for securing door hardware but this depends on door construction type.

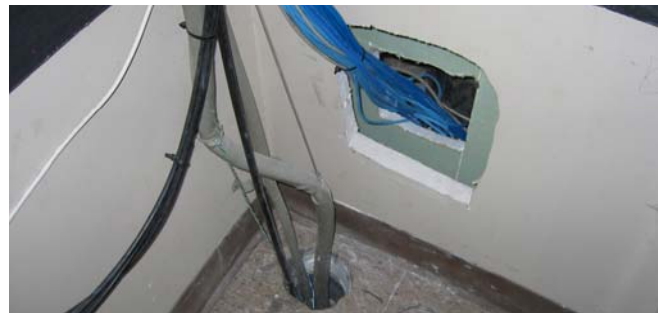
**Vertical penetrations are created by unsealed telecommunication and data cable penetrations. These penetrations exist but may not be limited to the following locations:**

- **100U2.**
- **200U3.**
- **300U3.**
- **400U3.**

This will permit rapid spread of smoke, heat and flame from one floor to the adjacent floor above. Penetrations for cables, cable trays, conduits, pipes, tubes, combustion vents and exhaust vents, wires, and similar items to accommodate electrical, mechanical, plumbing, and communications systems that pass through a wall, floor or floor/ceiling assembly constructed as a fire barrier shall be protected by a fire-stop system or device. The fire-stop system or device shall be tested in accordance with ASTM E-814 or ANSI/UL 1479.

**Remedy:** Survey all telecommunications closets, mechanical, and electrical rooms for unsealed penetrations and install protective devices as described above. See campus-wide deficiencies located at the end of this report concerning unsealed penetrations.

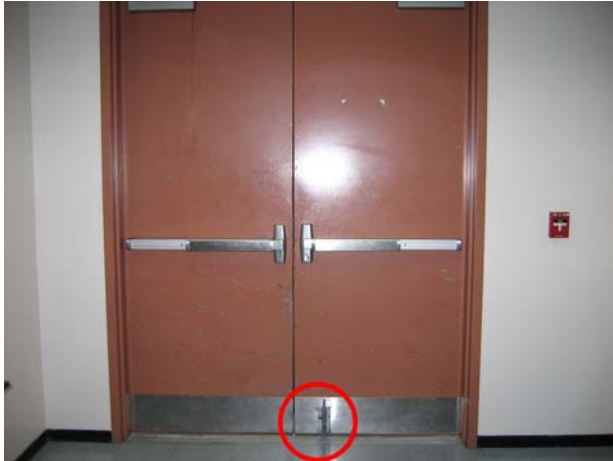
## FINDING #5

right hand door.

The double doors discharging from the 105 receiving to the loading dock are equipped with panic hardware but one incorporates an unapproved slide bolt latch located near the bottom edge.

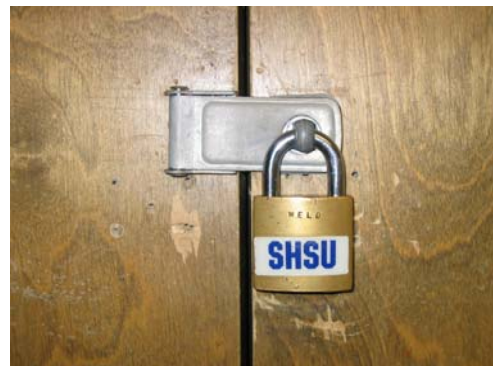
Unapproved devices may result in occupants being inadvertently locked in an area. .

**Remedy:** Replace the hasp and padlock with a releasing mechanism not requiring the use of a key, tool or special knowledge. Panic hardware shall release all other locking/latching devices on the doors.

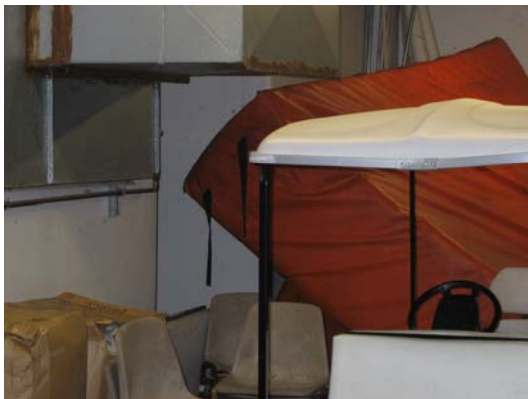
### **FINDING #9**

**A golf cart, high jump landing pad and chairs obstruct the storage area exit access door.**

These items reduce the width of the exit access corridor and may restrict groups of people during an emergency evacuation. Furnishings, decorations or other objects shall not obstruct exit access, egress or visibility.

**Remedy:** Relocate the items obstructing the egress door. See campus-wide deficiencies located at the end of this report concerning egress obstructions and impediments.

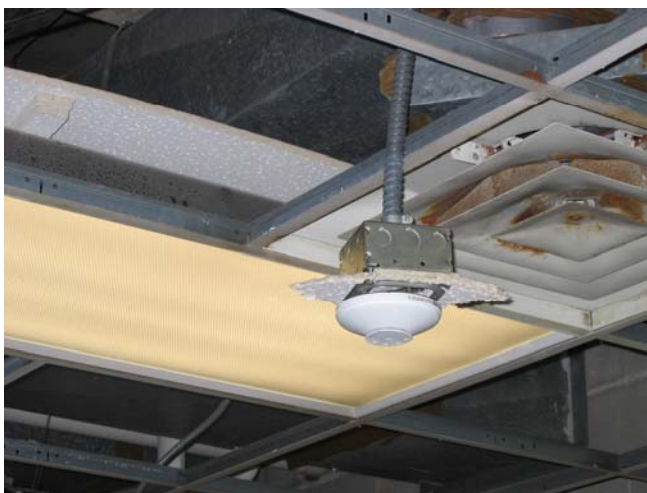
**A heat detector is installed on the ceiling grid but most of the grid's tiles are missing.**

The lack of ceiling tiles will delay activation of the heat detector. The missing tiles require the interstitial space above the grid to fill with heat prior to reaching the elevation of the heat detector. The delay in detection and subsequent activation of the fire alarm system endangers occupants.

**Remedy:** Replace the missing ceiling tiles.

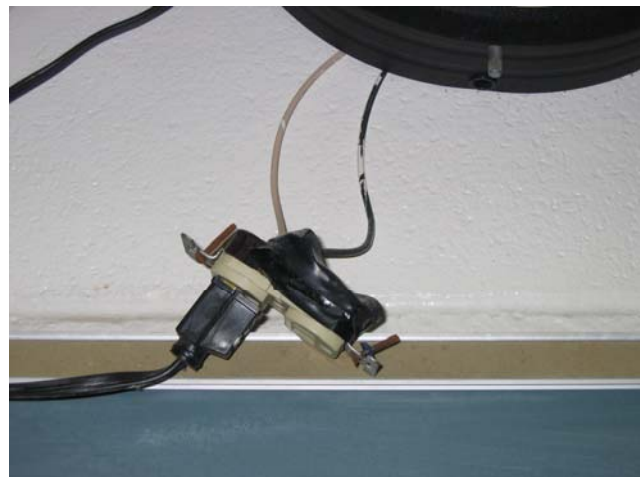
#### **FINDING #21**

**A wall clock in the track and field dressing room was supplied by an electrical receptacle outlet that is not secured in a receptacle box. This outlet's energized terminals are covered with tape in an effort to prevent contact with energized circuits. The clock was disconnected during the inspection.**

Electrical installations must be installed in accordance with NFPA 70, *National Electrical Code*, to limit the possibility of an electrical fire or shock.

**Remedy:** Repair the electrical outlet or remove the outlet and cover the electrical outlet box containing the energized conductors.

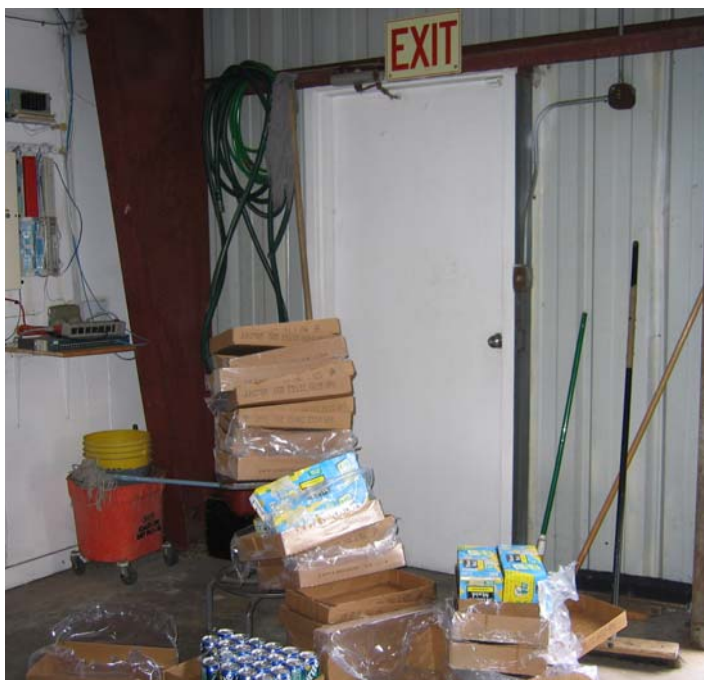
**A chair and stacks of empty cardboard boxes obstruct access to the front exit door.**

These obstructions will hinder egress. Furnishings, decorations or other objects shall not obstruct exit access, egress or visibility.

**Remedy:** Remove the items obstructing the exit and see campus-wide deficiencies located at the end of this report concerning egress obstructions and impediments.

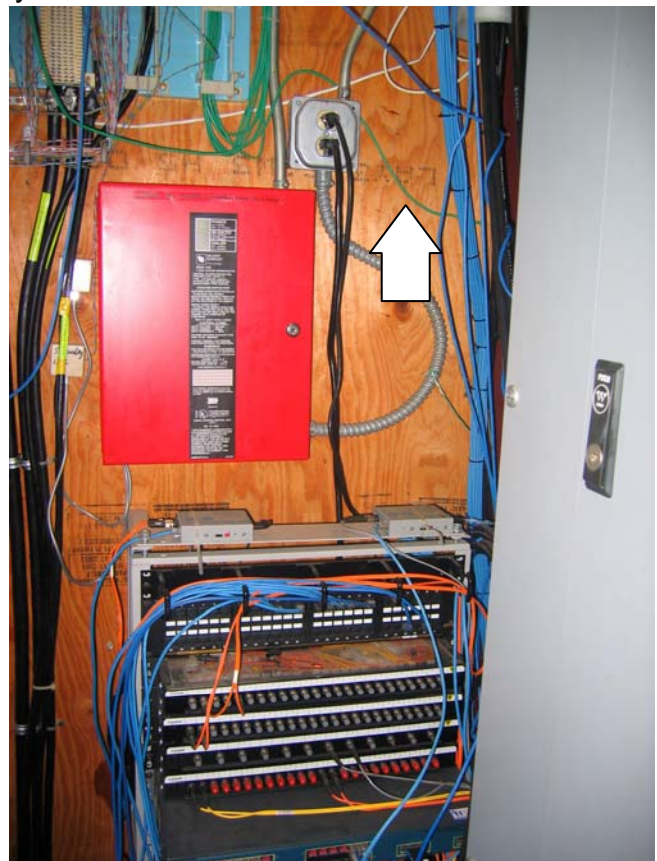
**Fire alarm deficiencies exist and include the following:**

- **The automatic dialer circuit is altered to include power to computer servers.**
- **The service tag indicates it was last serviced on 1994.**

Fire alarm systems require dedicated power supplies. Inadequate servicing will result in this and other types of deficiencies.

**Remedy:** Implement the following corrective measures:

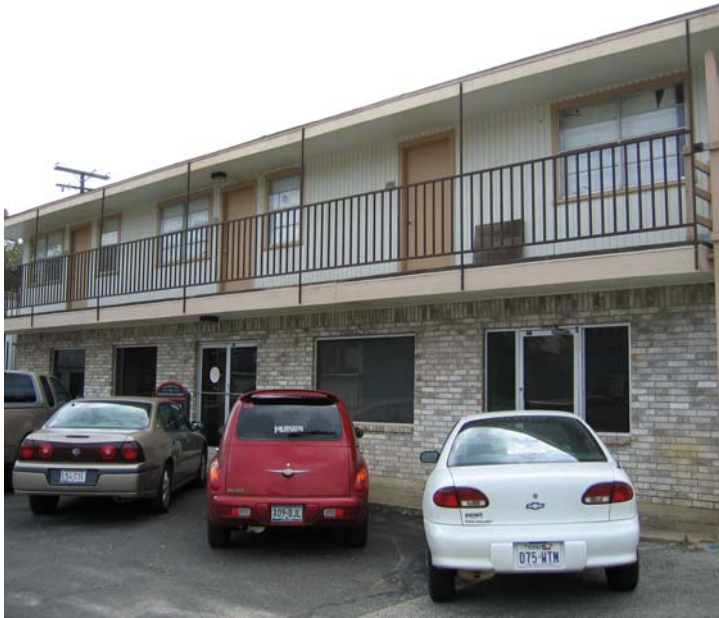
#### **FINDING #1**

**The second story egress has an 80 foot dead-end corridor, which exceeds limitations. This deficiency is compounded due to the existence of unprotected window and door openings.**

Dead-end corridors require occupants traversing this area to reverse their direction. This increases evacuation times. A fire occurring in one of the rooms along this dead-end will quickly penetrate the unprotected openings, subsequently preventing egress from numerous other rooms.

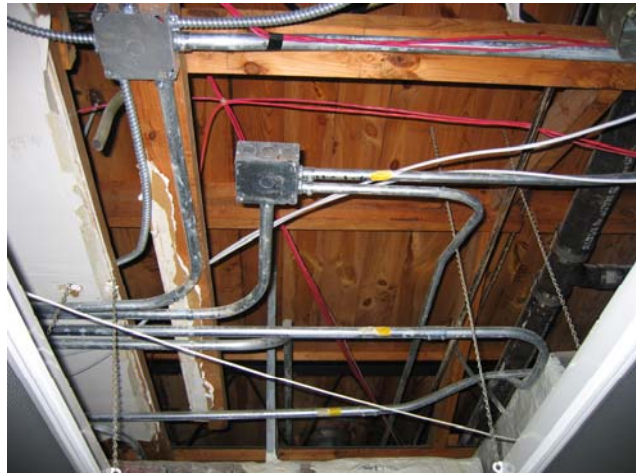
**The first floor mechanical room ceiling area is exposed to combustible wood decking at the second floor level. Mechanical rooms and similar areas are considered hazardous and thus require a minimum separation from other areas.**

The lack of separation between the mechanical room and other areas may permit the rapid spread of fire from the mechanical room to other occupied spaces.

**Remedy:** Two alternatives exist:

Provide a minimum one hour fire separation. This should include the walls and ceiling area. Doors entering this room shall incorporate door closing devices, positive latching and the door shall have a minimum 45 minute fire rating.

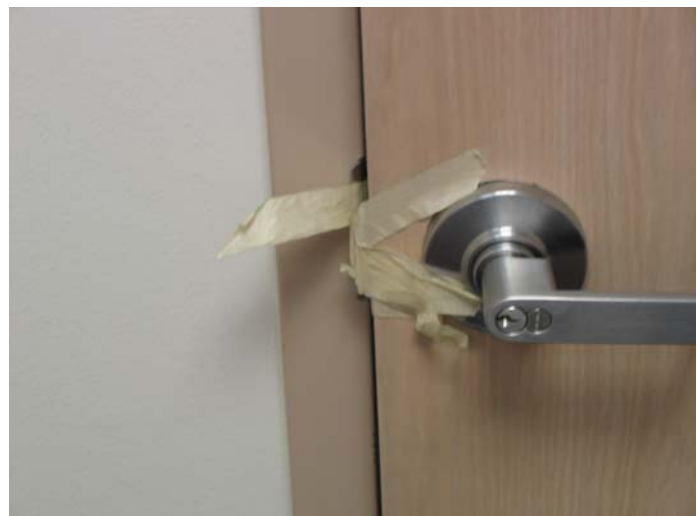
**The janitor's closet door latching mechanism was taped in the retracted position. Upon removing the tape, the door would not fully close to a latched position.**

The lack of separation between the janitor's closet/hazardous area and the remainder of the building may permit the rapid spread of fire from this room to

other areas.

**Remedy:** Repair and/or replace the latching mechanism to ensure that the door fully closes and latches when not in use.

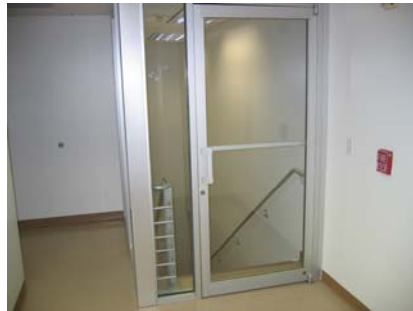
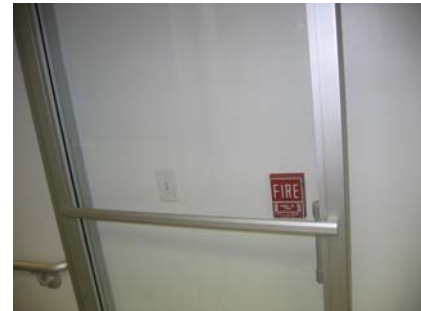
#### **FINDING #4**

**The glass partition door located at the top of the stairs obstructs the manual fire alarm pull box when the door is in the open position.**

Each manual fire alarm box on a system shall be accessible, unobstructed, and visible to permit quick activation of the fire alarm system.

**Remedy:** Remove the door or relocate the manual fire alarm pull box so the door will no longer obstruct it when the door is opened.

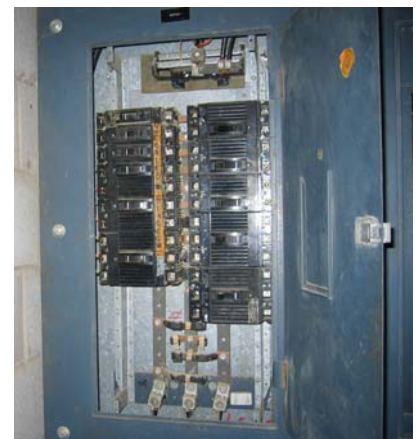
#### **FINDING #3**

**The section 1 electrical panel box located in the electrical room is missing its required cover.**

Without an approved cover a person has access to the high voltage electrical wiring and may become electrocuted. Introduction of a foreign object may also result in shorting, subsequently igniting nearby combustibles.

**Remedy:** Replace the missing electrical panel cover.

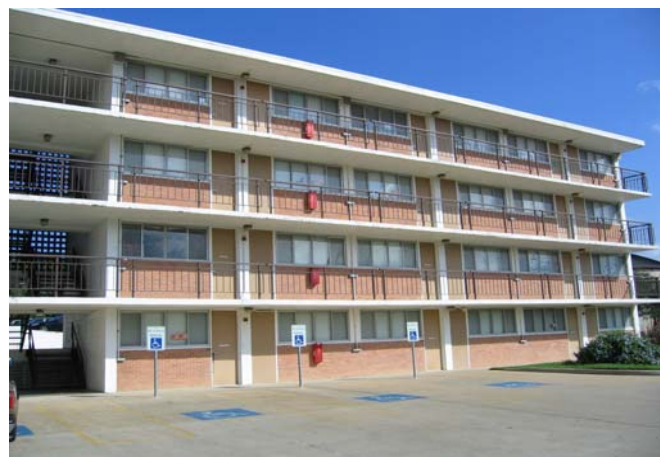
This building incorporates dead-end balconies, which require occupants evacuating rooms to traverse past unprotected openings. The lack of door-closing devices and rated windows will permit rapid spread of smoke, heat and flame from a room into the exterior egress balconies, subsequently blocking egress.

**Remedy:** Install self-closing devices on every door entering dead-end portions of the exterior balconies and replace the existing windows with windows consisting of wired glass or its equivalent.

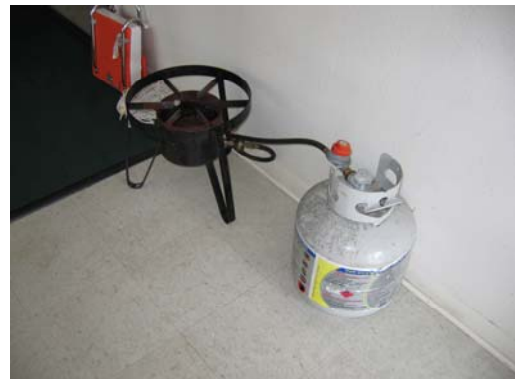
**A propane tank is improperly stored in apartment #200 of Colony building I and a gasoline can is improperly stored in apartment #100 of Colony building H.**

The contents of residential occupancies are classified as ordinary hazard. This prevents storage of flammable substances that might endanger occupants or fire fighters. Propane storage is not permitted. Otherwise, storage of other flammables result in areas being categorized as hazardous areas, which require separation and/or protection in accordance with Chapter 8.7.

**Remedy:** Implement the following corrective measures:

- Remove the propane bottle.
- Provide an approved one hour rated enclosure and/or sprinkler protection for the storage of gasoline or remove it from the building.

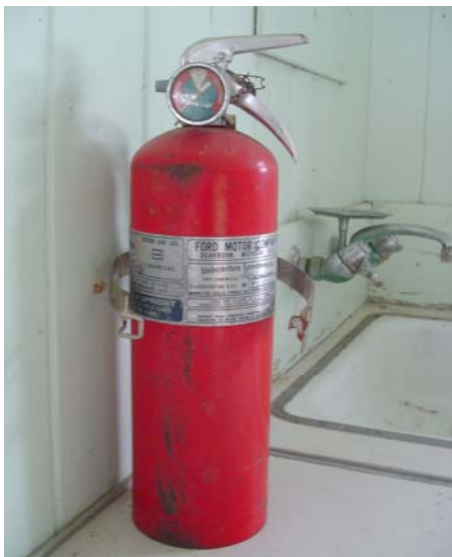
**The pressure gauges of the dry chemical fire extinguishers located on the countertop in the garage and within the closet of the second-floor apartment indicate a loss of operating pressure.**

Portable fire extinguishers must be serviced at least once annually or when deficiencies exist such as the loss of internal pressure. This ensures proper operation in case of a fire. Any device, equipment, system, condition, arrangement, level of protection, or any other feature required for compliance with the provisions of the Life Safety Code shall thereafter be permanently maintained unless the Life Safety Code exempts such maintenance.

**Remedy:** Have the portable fire extinguishers serviced by a licensed company. See campus-wide deficiencies located at the end of this report concerning maintenance and testing of fire protection equipment.

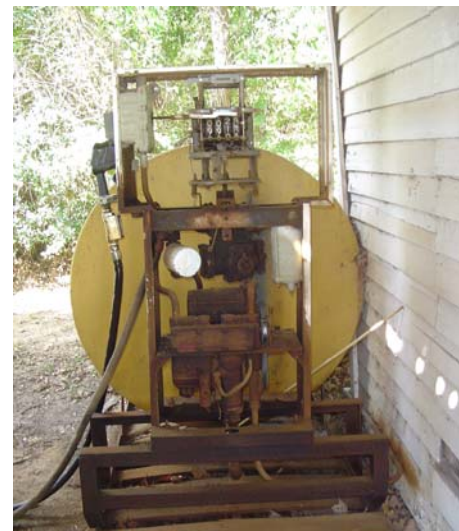
This complex has two aboveground fuel storage tanks (ASTs). One of the ASTs is an approximately 1,000 gallon steel tank and dispenser assembly used for fueling diesel-powered farm equipment. This system incorporates a suction type pump system. It is located in direct contact with the wood frame barn. The other AST is an approximately 300 gallon steel tank on a steel stand. Fuel is dispensed into diesel-powered farm equipment by gravity flow. The aboveground storage tanks and dispenser assemblies are not in compliance with the less restrictive standards for applicable to farms and ranches located in remote

areas and as per NFPA 30A, *Code for Motor Fuel Dispensing Facilities and Repair Garages, Chapter 13*.

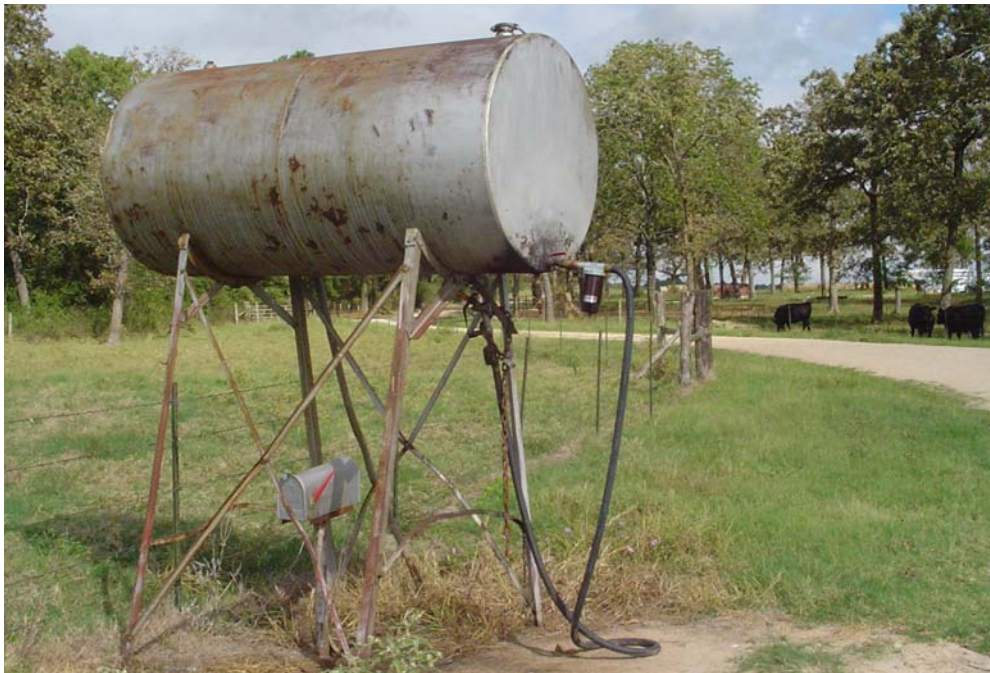
**The aboveground storage tanks and dispenser assemblies lack compliance with less restrictive standards permitted for farms and ranches located in remote areas as per NFPA 30A, *Code for Motor Fuel Dispensing Facilities and Repair Garages, Chapter 13*.**

- Hose used for dispensing Class II (diesel) shall be equipped with listed self-closing nozzles.

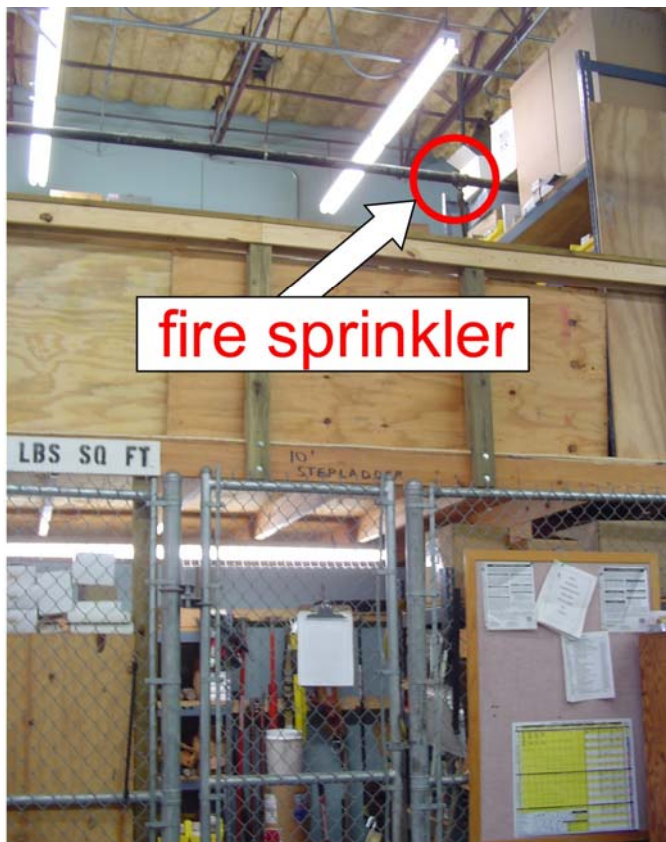
Offices and storage mezzanines constructed in areas of the building neglected to include required modification of the fire sprinkler system. These areas include:

- Office 161C.
- Storage mezzanine in Electrical Shop 158.
- Storage mezzanine in Residence Maintenance 159.

The creation of several large unprotected areas will permit a fire in these areas to grow beyond the extinguishing capability of the fire sprinkler system. This threatens occupants and will result in unnecessary property damage, which may include the complete loss of this building.

**Remedy:** Implement the following corrective measures:

- Contact a state-licensed fire sprinkler firm to survey the fire sprinkler coverage in this

building. Sprinklers shall be installed under fixed horizontal obstructions over four feet wide, such as ducts, decks, open grate flooring and overhead doors.

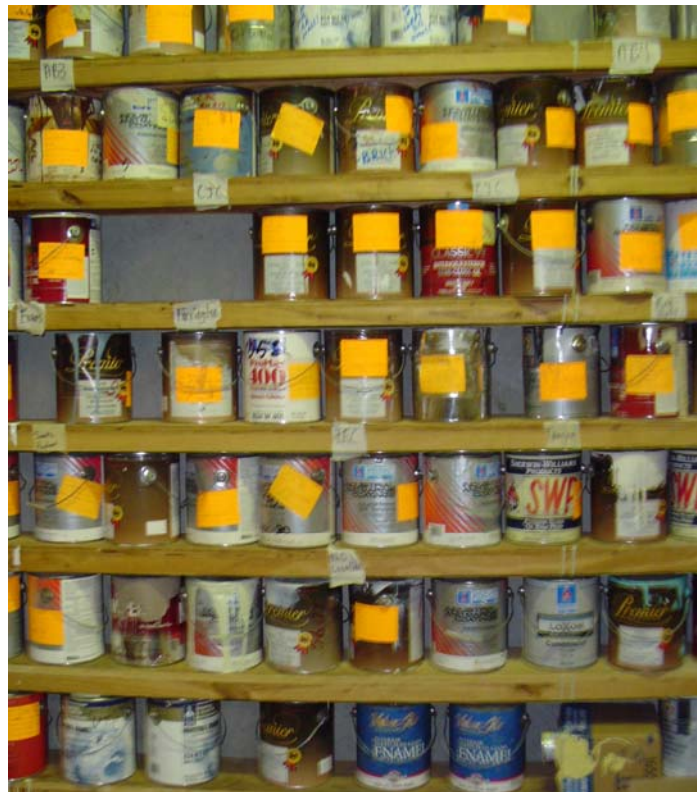
Paint shop 152A is a storage room that contains unapproved storage of a large quantity of flammable and combustible paints and solvents. This room fails to meet requirements for inside storage areas as established in Chapter 6.4 of *NFPA 30, Flammable and Combustible Liquids Code*. Deficiencies include:

- Lack of ventilation.
- Lack of spill control.
- Lack of openings in the exterior wall for firefighting.
- Lack of vapor proof electrical and appurtenances such as lighting fixtures.

**Remedy:** Implement the following corrective measures:

- Prohibit dispensing or transfer of liquids unless ventilation and spill control equipment is installed.
- Limit individual containers to not more than a 10 gallon capacity.

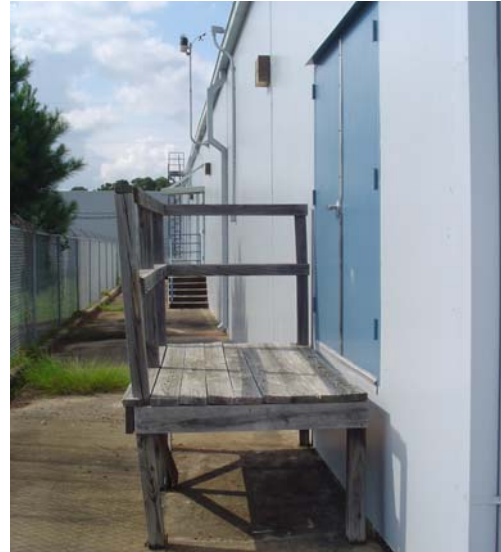
The exterior exit from Computing Services 171B discharges onto a wood deck that is elevated above the ground level. This deck lacks required stairs to reach grade.

The lack of required stairs eliminates a safe manner of discharge from the deck. Changes in level in means of egress shall be achieved by a stairway or ramp complying with the dimensional requirements of the Life Safety Code where the elevation difference exceeds 21 inches.

**Remedy:** Install an approved set of stairs or a ramp from the deck.

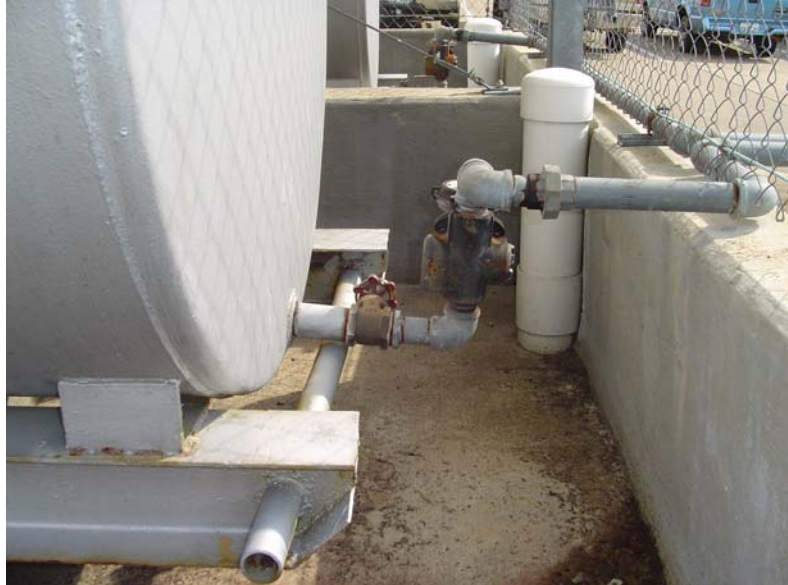
Any emergency occurring during filling operations may result in a fire involving the tank and fuel truck.

**Remedy:** Provide an area that permits a minimum 25 feet separation from the ASTs and the delivery vehicle.
