**Texas Department of Insurance**

Re: Fire Safety Inspection RRO000000005301A

## **Sam Houston State University Fire Safety Inspection Report**

**Sam Houston State University**  
**Executive Summary**

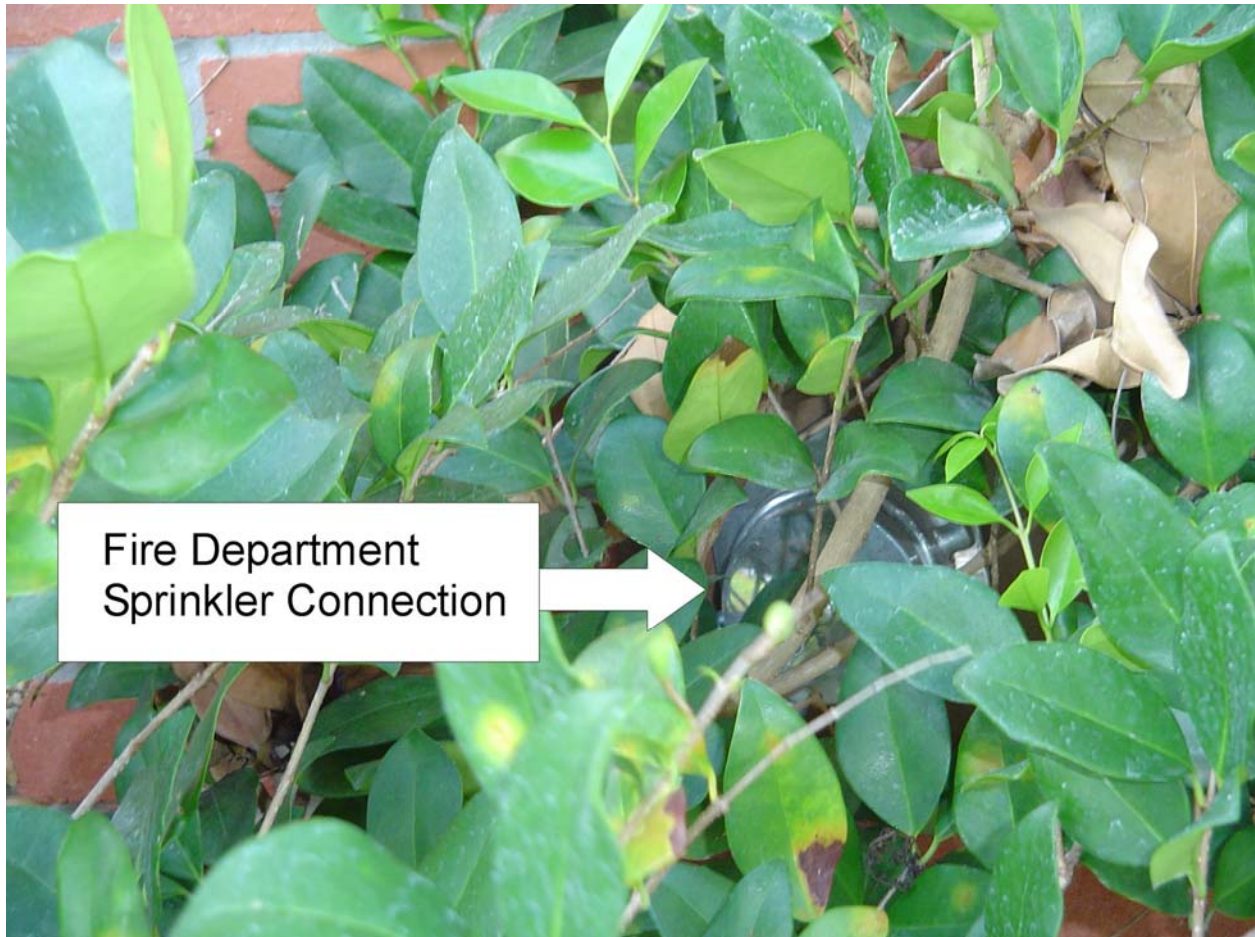
The sprinkler system fire department connection is covered by bushes and thus not readily visible from the street.

The lack of visibility may delay fire department access, subsequently delaying its suppression efforts.

**Remedy:** The following corrective measures are necessary:

- Remove the landscaping obstructing the fire department connection.
- Develop a program of regular inspection of fire department connections to meet the following criteria:
- SHSU shall inspect fire department connections at least once quarterly. This inspection shall verify the following:
  - Visibility and accessibility of fire department connections.
  - Verify couplings and swivels are not damaged and rotate smoothly.
  - Plugs or caps are in place and undamaged.
  - Gaskets are in place and in good condition.
  - Identification signs exist.

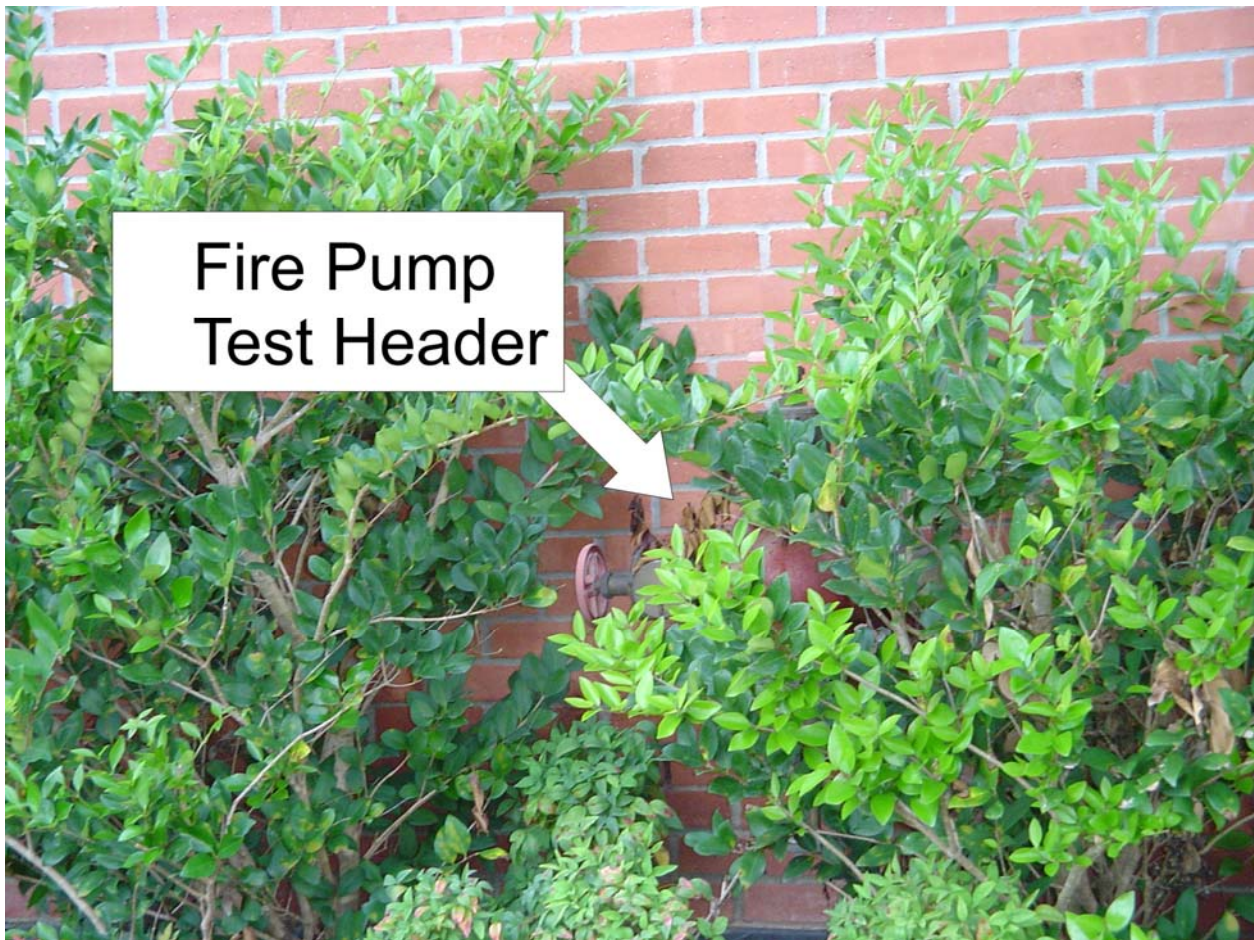
**NOTE:** The fire pump test header for the fire sprinkler system is covered with bushes and is not readily accessible to perform flow testing. Remove bushes from around the fire pump test header to facilitate regular pump testing.

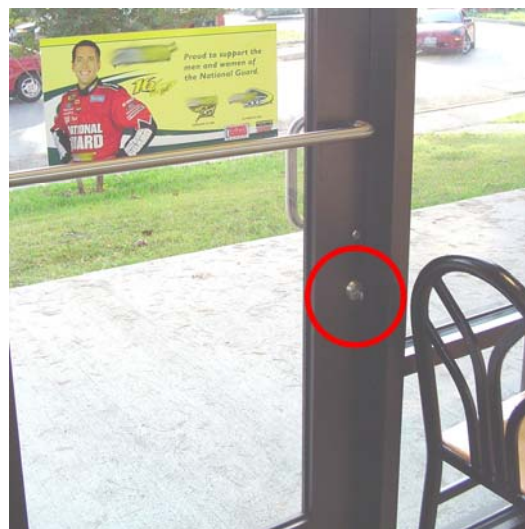
Unapproved hardware may prevent rapid evacuation during an emergency. Egress doors subject to 100 or more occupants must incorporate panic hardware to facilitate rapid evacuations.

**Remedy:** Remove the existing locking hardware and install approved panic or fire exit hardware. See campus-wide deficiencies located at the end

of this report concerning unapproved locking and/or latching devices.

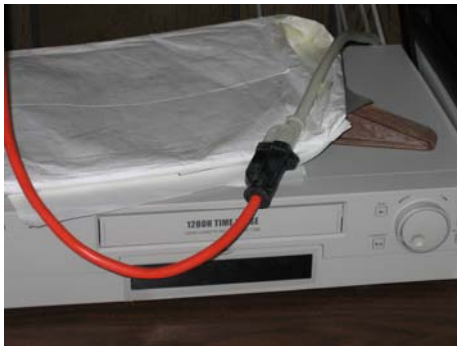
**Extension cords are improperly used in various areas, including the following locations:**

- Back office behind the front desk.
- Rooms 306.
- Room 326.
- Room 405.

Extension cords are designed and intended for use as temporary wiring. They should not be used as a substitute for permanent wiring.

**Remedy:** Discontinue use of the extension cords and see campus-wide deficiencies located at the end of this report concerning the use of extension cords.
